Owens River Water Trail Final EIR Overview & Board Recommendation

Inyo County Water Commission
CEQA Adequacy Review

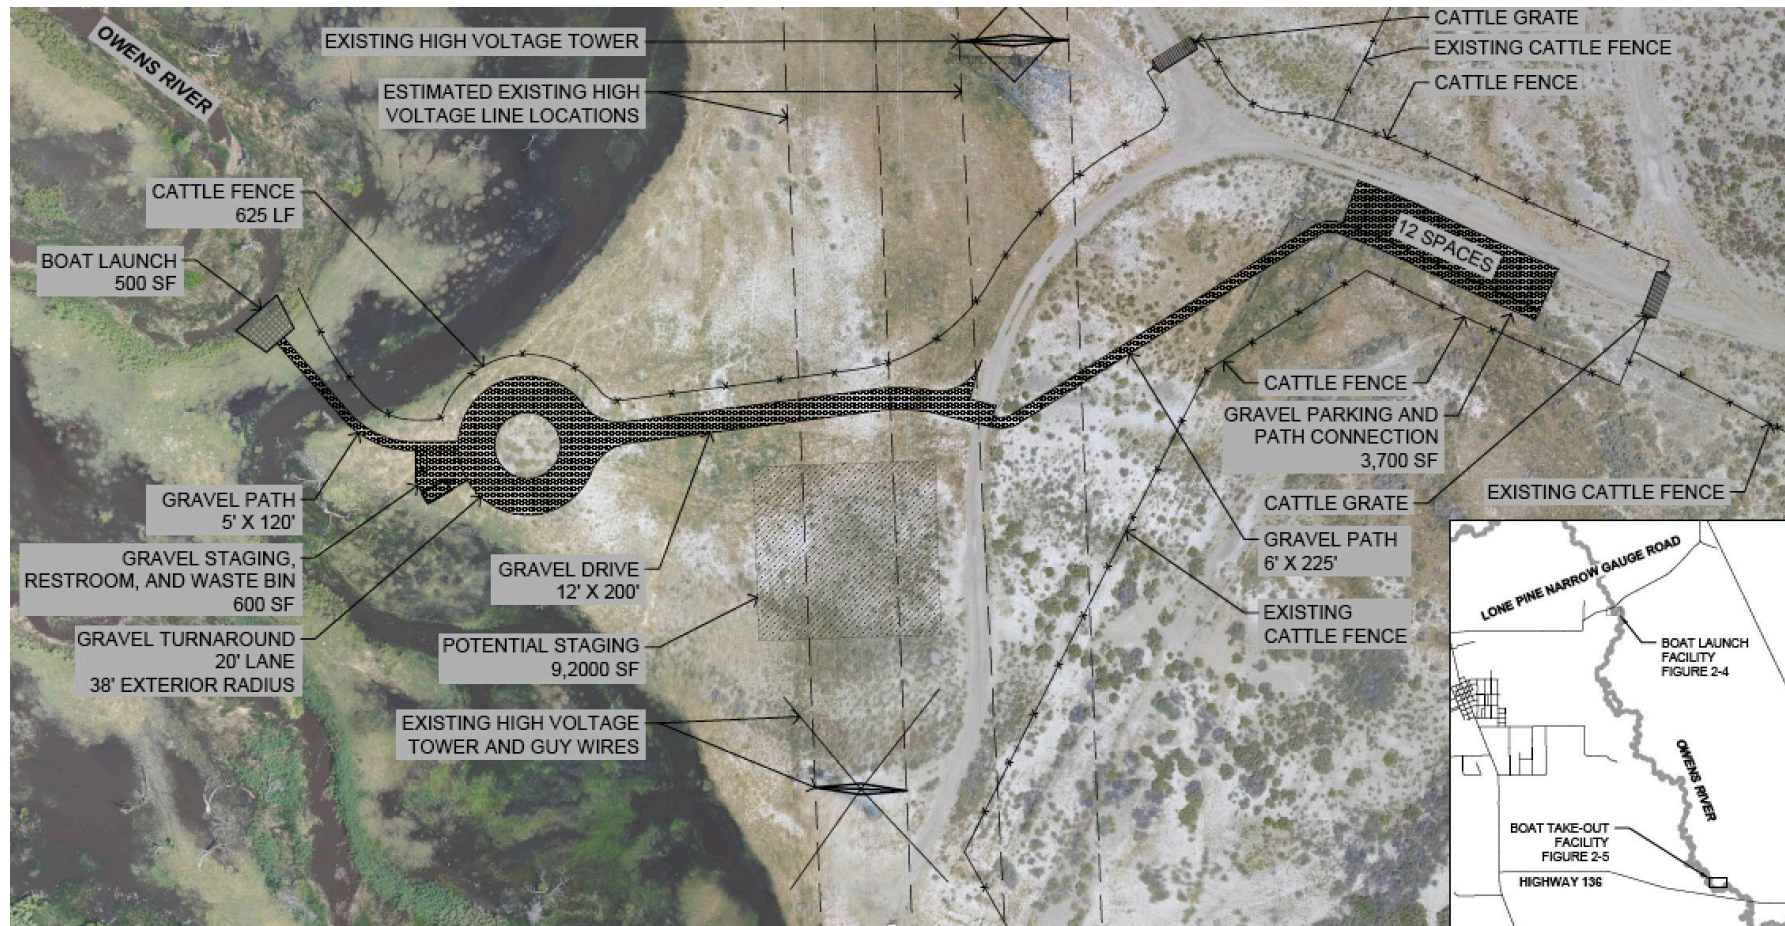
BACKGROUND AERIAL SOURCE: INYO COUNTY
INUNDATION: 190 CFS ON JULY 7, 2017

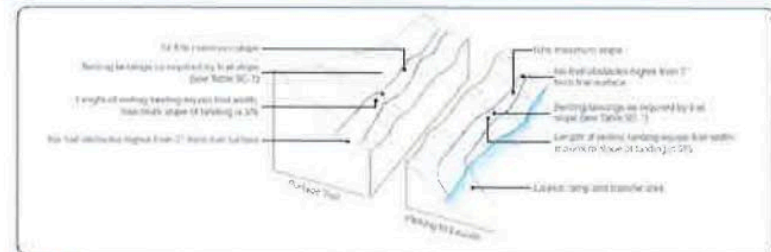
Figure 30-4
Acquisition ARA Successes by Year Ended

Water trail developers are encouraged to design and construct trails to meet Accessible ADA standards. Differences between accessible and non-accessible trails include slope, resting intervals, trail width, and height of protrusions. Figures 30-4 and 30-5 illustrate trail elements designed to meet ADA standards for accessible design.

Required resting intervals are a notable difference between accessible and non-accessible trail design. Resting intervals are mini-level surfaces placed at varying distances inward on trail rings (Table 3C-1). On older trail networks designed to meet universal design standards, a hard-surface staging area is required adjacent to either the accessible parking stalls or the loading lane (Figure 3C-4).

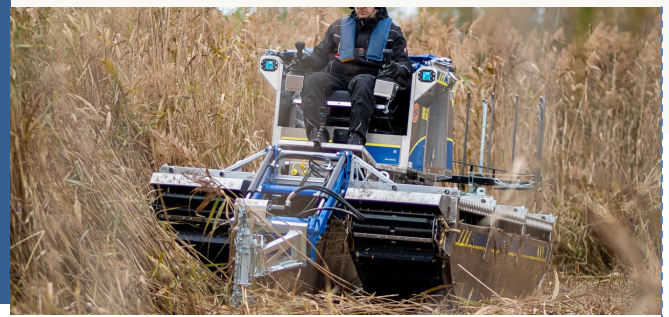
Emergent vegetation removed to
restore navigable channel

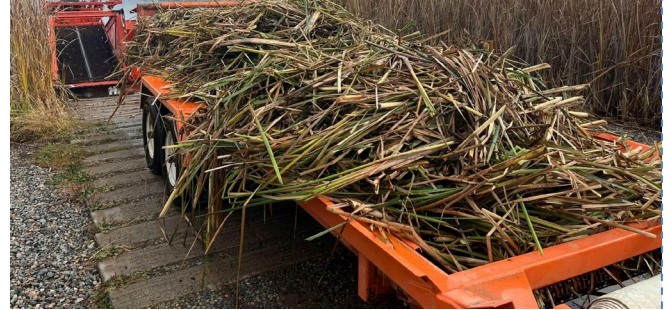
Excavated material thin-spread in
designated areas to compost

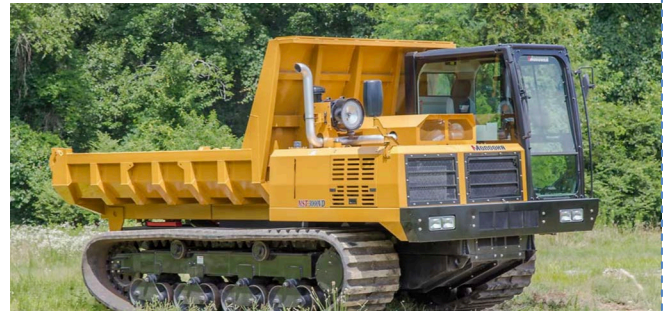
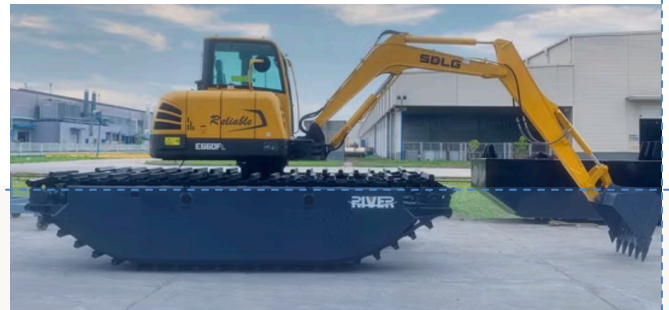
Spoils areas monitored for recovery
