HAY RANCH PROJECT INYO COUNTY CONDITIONAL USE PERMIT HYDROLOGIC MONITORING REPORT

THIRD QUARTER 2025

**RE: Hay Ranch Project Conditional Use Permit
Hydrologic Monitoring Report, Third Quarter 2025
Inyo County, California**

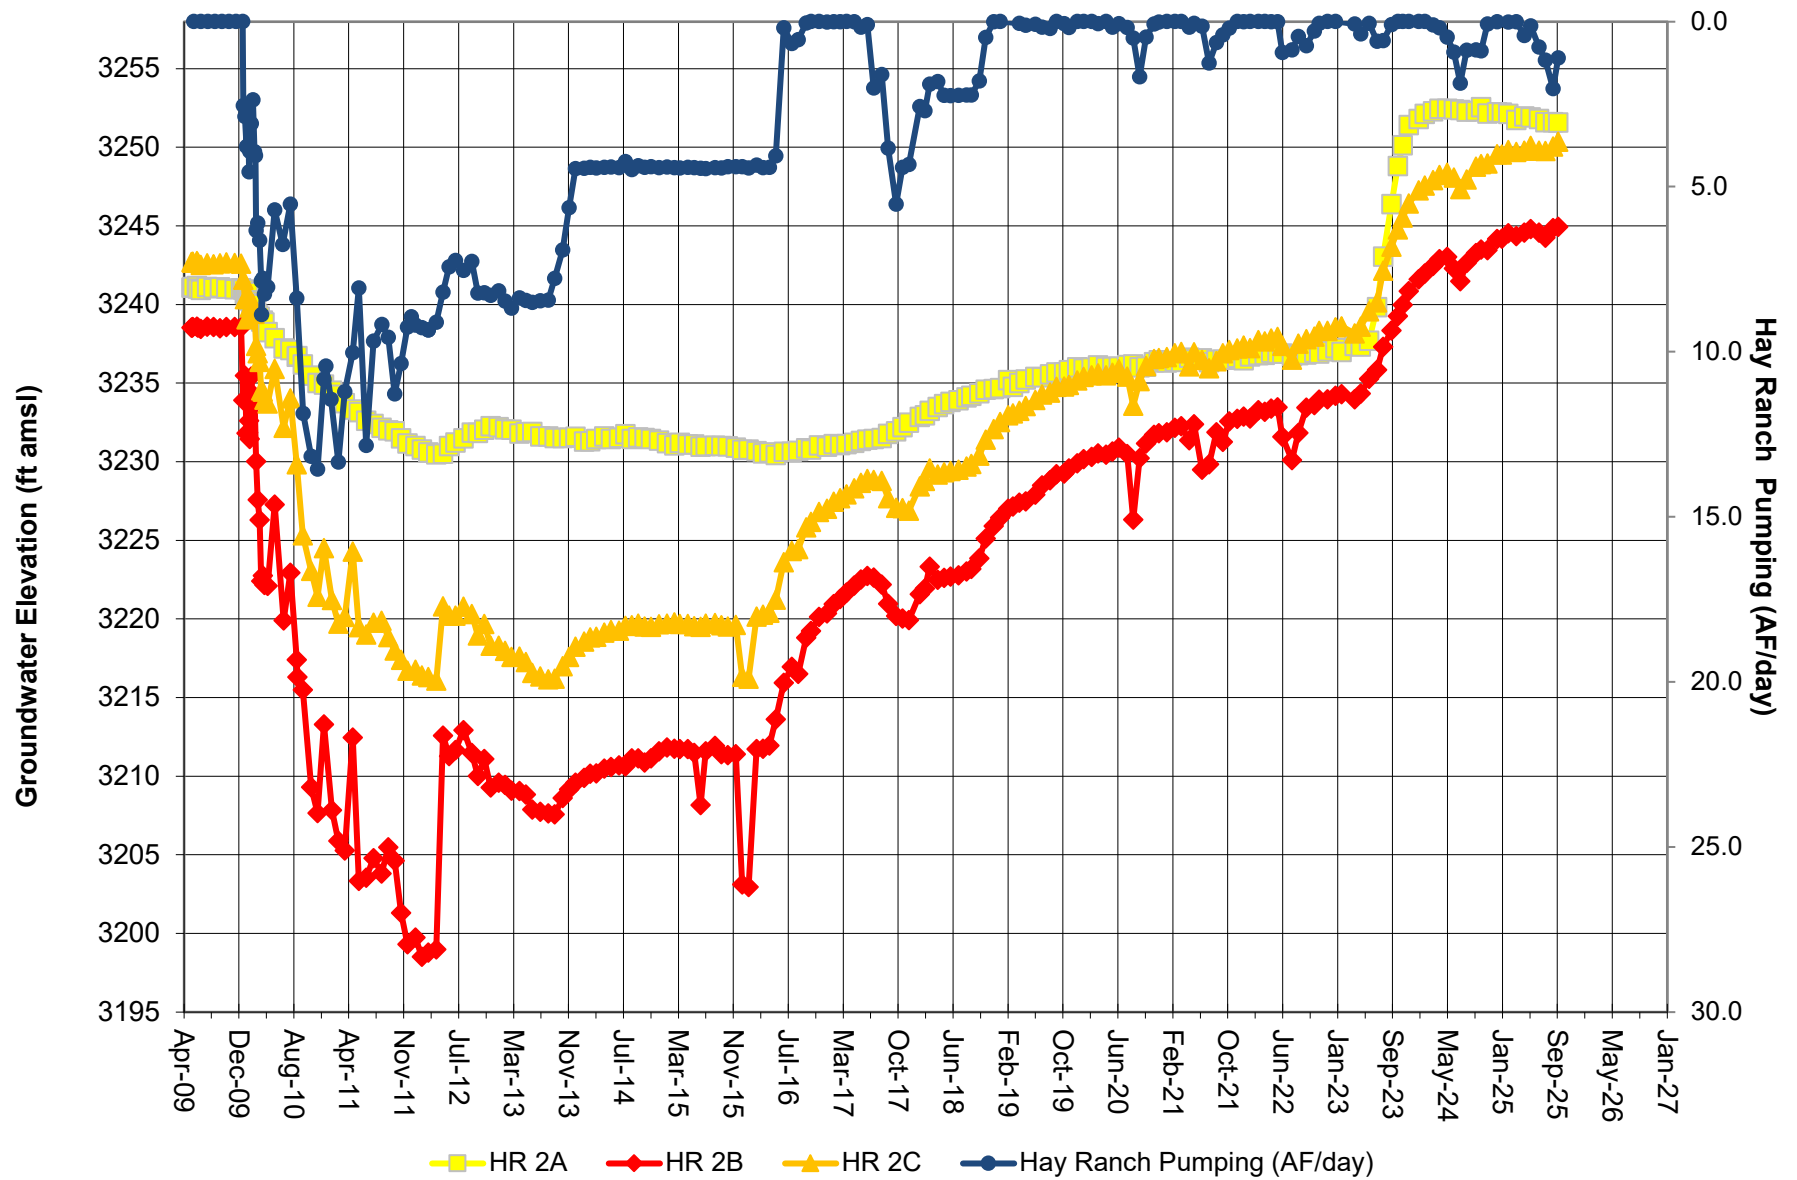
FIGURE 5
GROUNDWATER ELEVATION and HAY RANCH PUMPING
HR 2A, HR 2B and HR 2C

Note: Groundwater elevation data based on manual depth-to-water measurements.
Hay Ranch pumping is average acre feet per day.

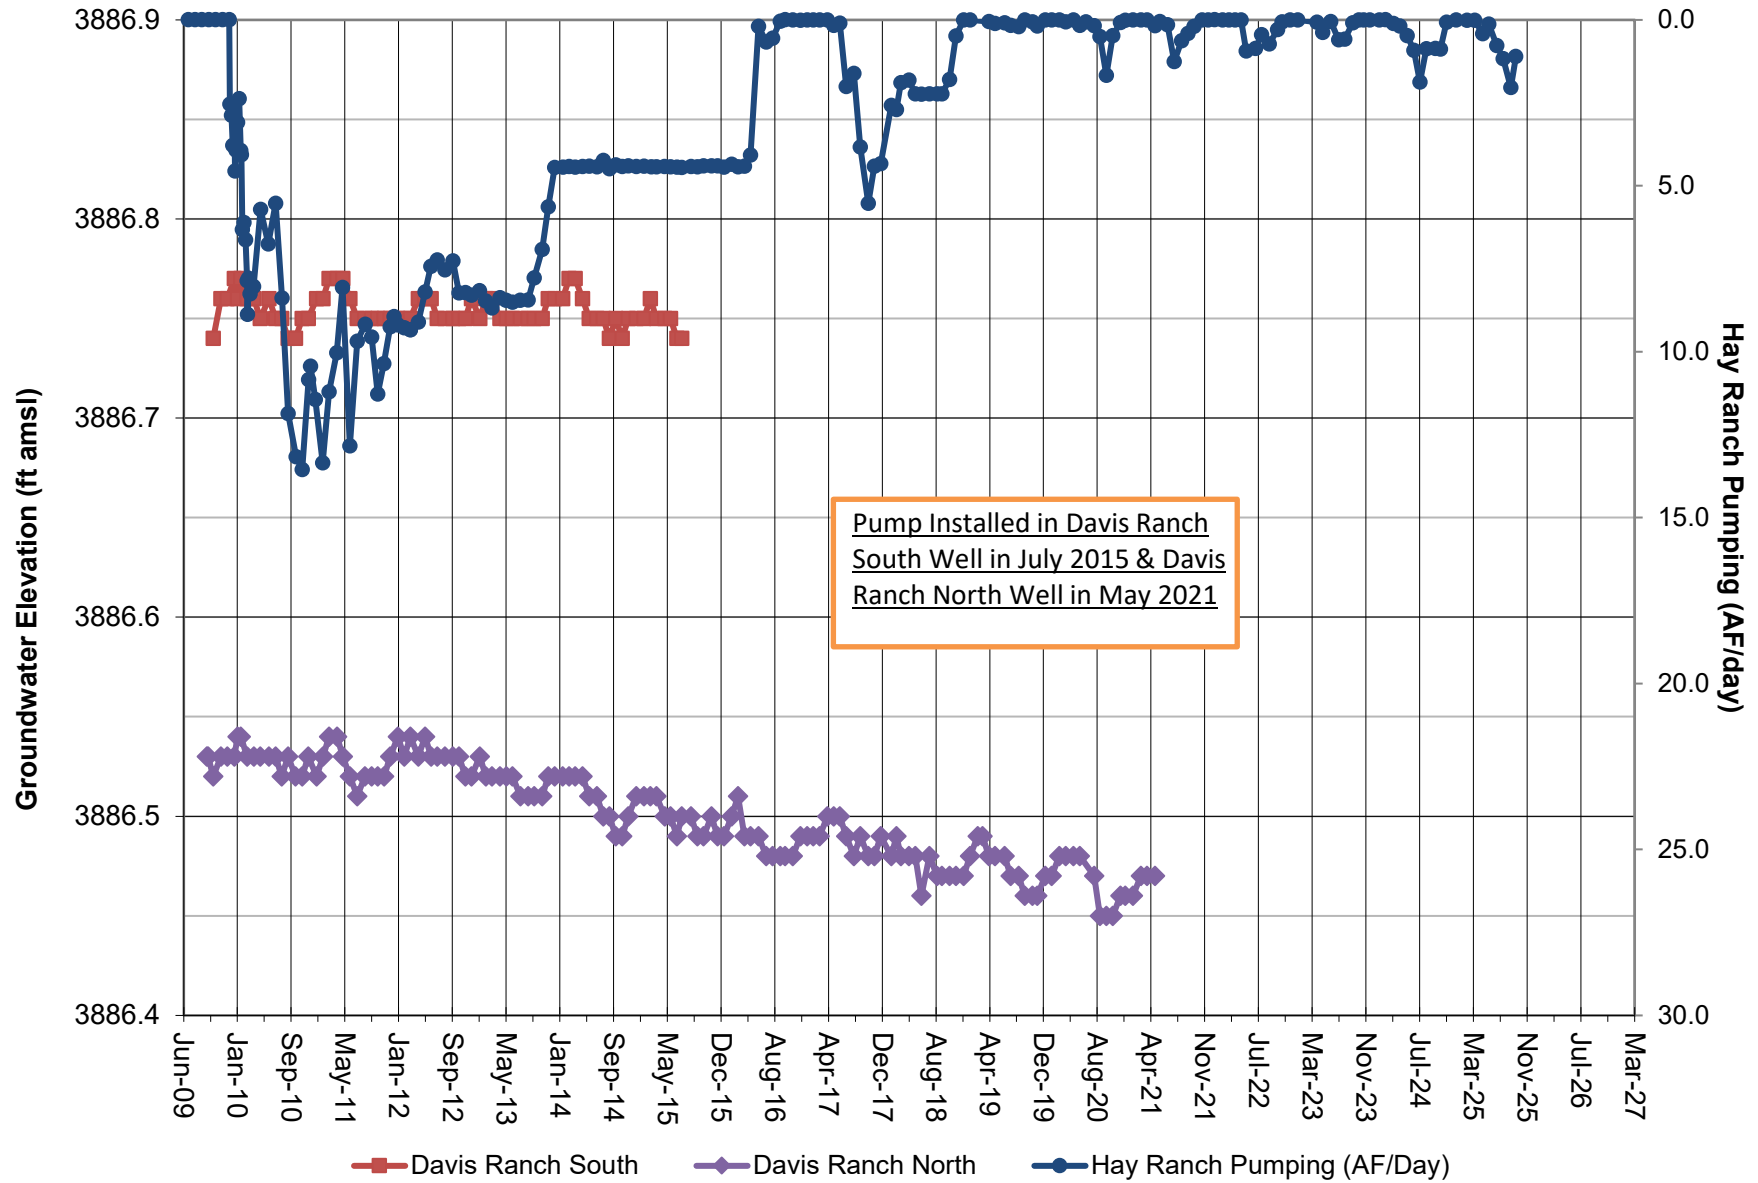
FIGURE 7
GROUNDWATER ELEVATION and HAY RANCH PUMPING
Davis Ranch North and South

Note: Groundwater elevation data based on manual depth-to-water measurements.
Hay Ranch pumping is average acre feet per day.

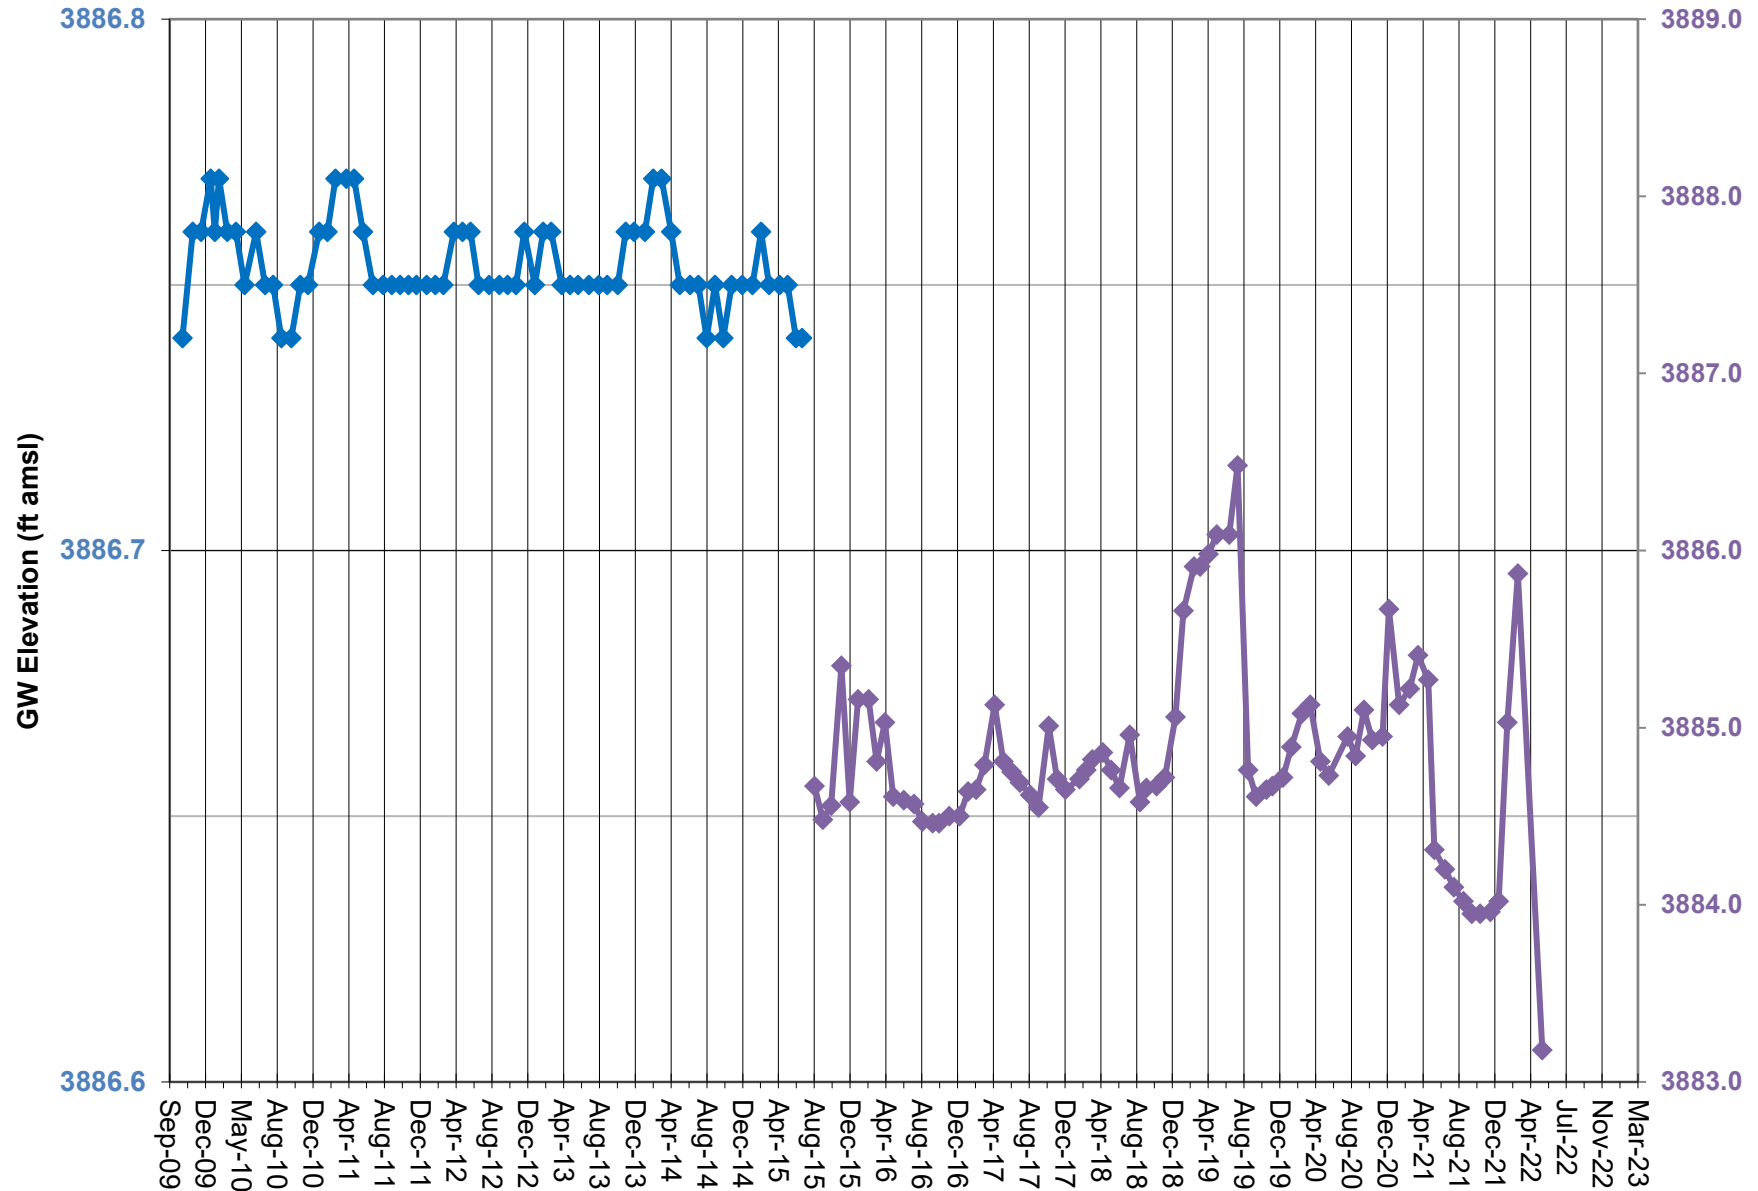
Note: Groundwater elevation data based on manual depth-to-water measurements.
Water-supply pump installed in DR South in July 2015.
Note secondary axis for GWEs post-pump installation.
