### GROUNDWATER ELEVATION DATA - Transducer RV060 - HR 1A Well

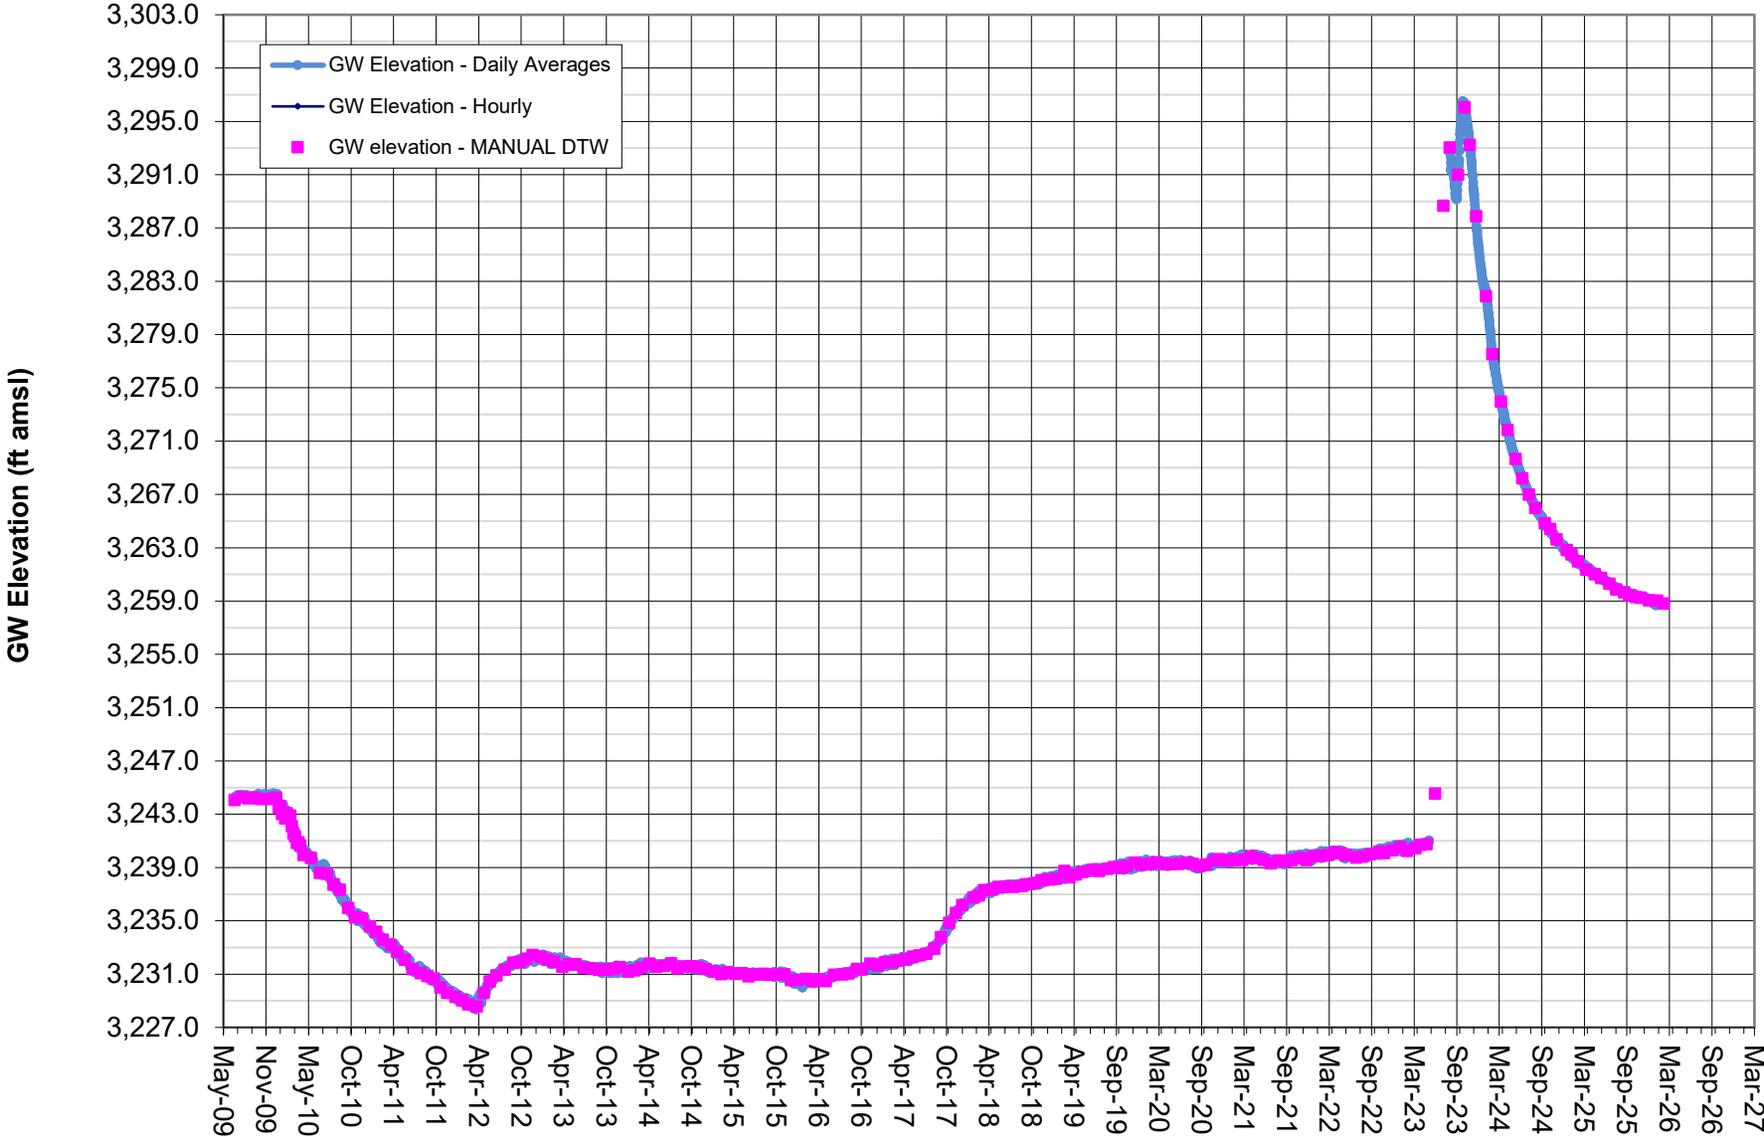
Note: Screened interval 170-260 feet.  
 Coso Operating Co. initiated Hay Ranch Project pumping on 12/25/09.  
 HR1A data gaps due to transducer malfunction. Transducer replaced 8/16/23

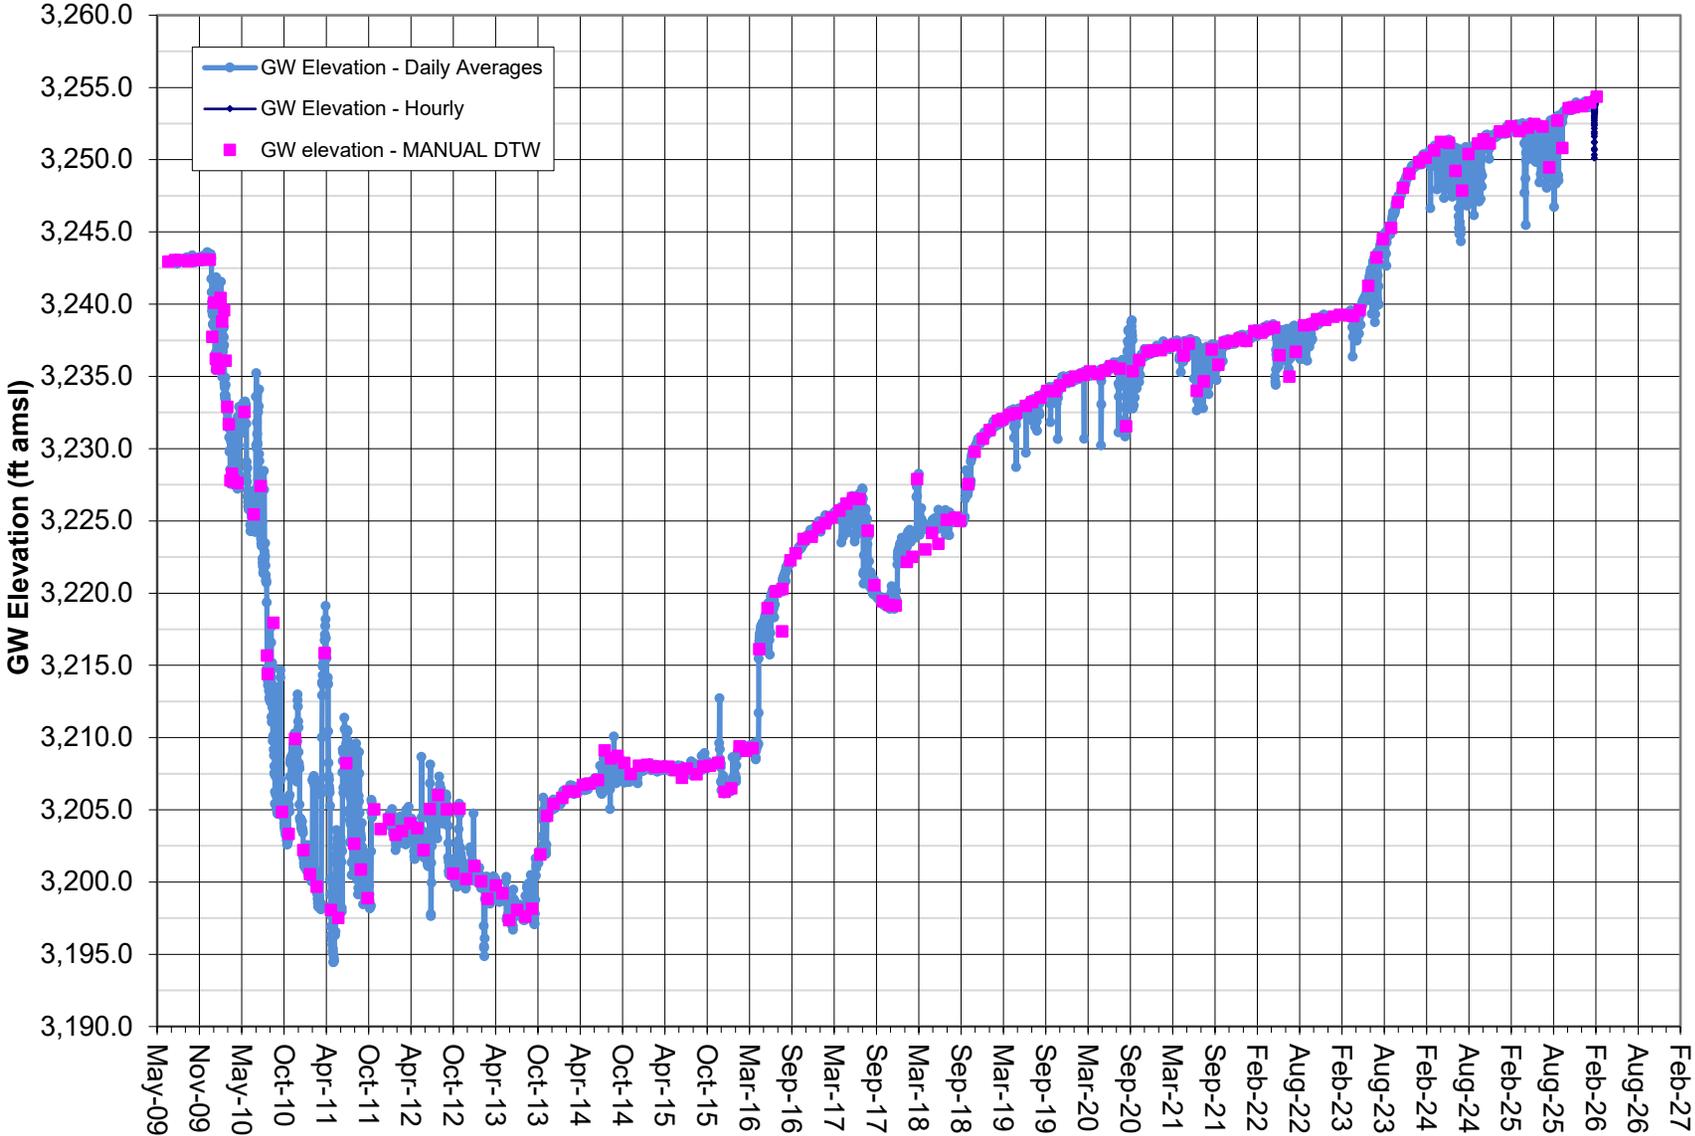
### GROUNDWATER ELEVATION DATA - Transducer RV061 - HR 1B Well

Note: Screened interval 490-540 feet.  
 Transducer data (absolute pressure) adjusted by data logged from BaroTroll and correlated to Manual DTW measurements.  
 Data gaps are due to transducer malfunction.

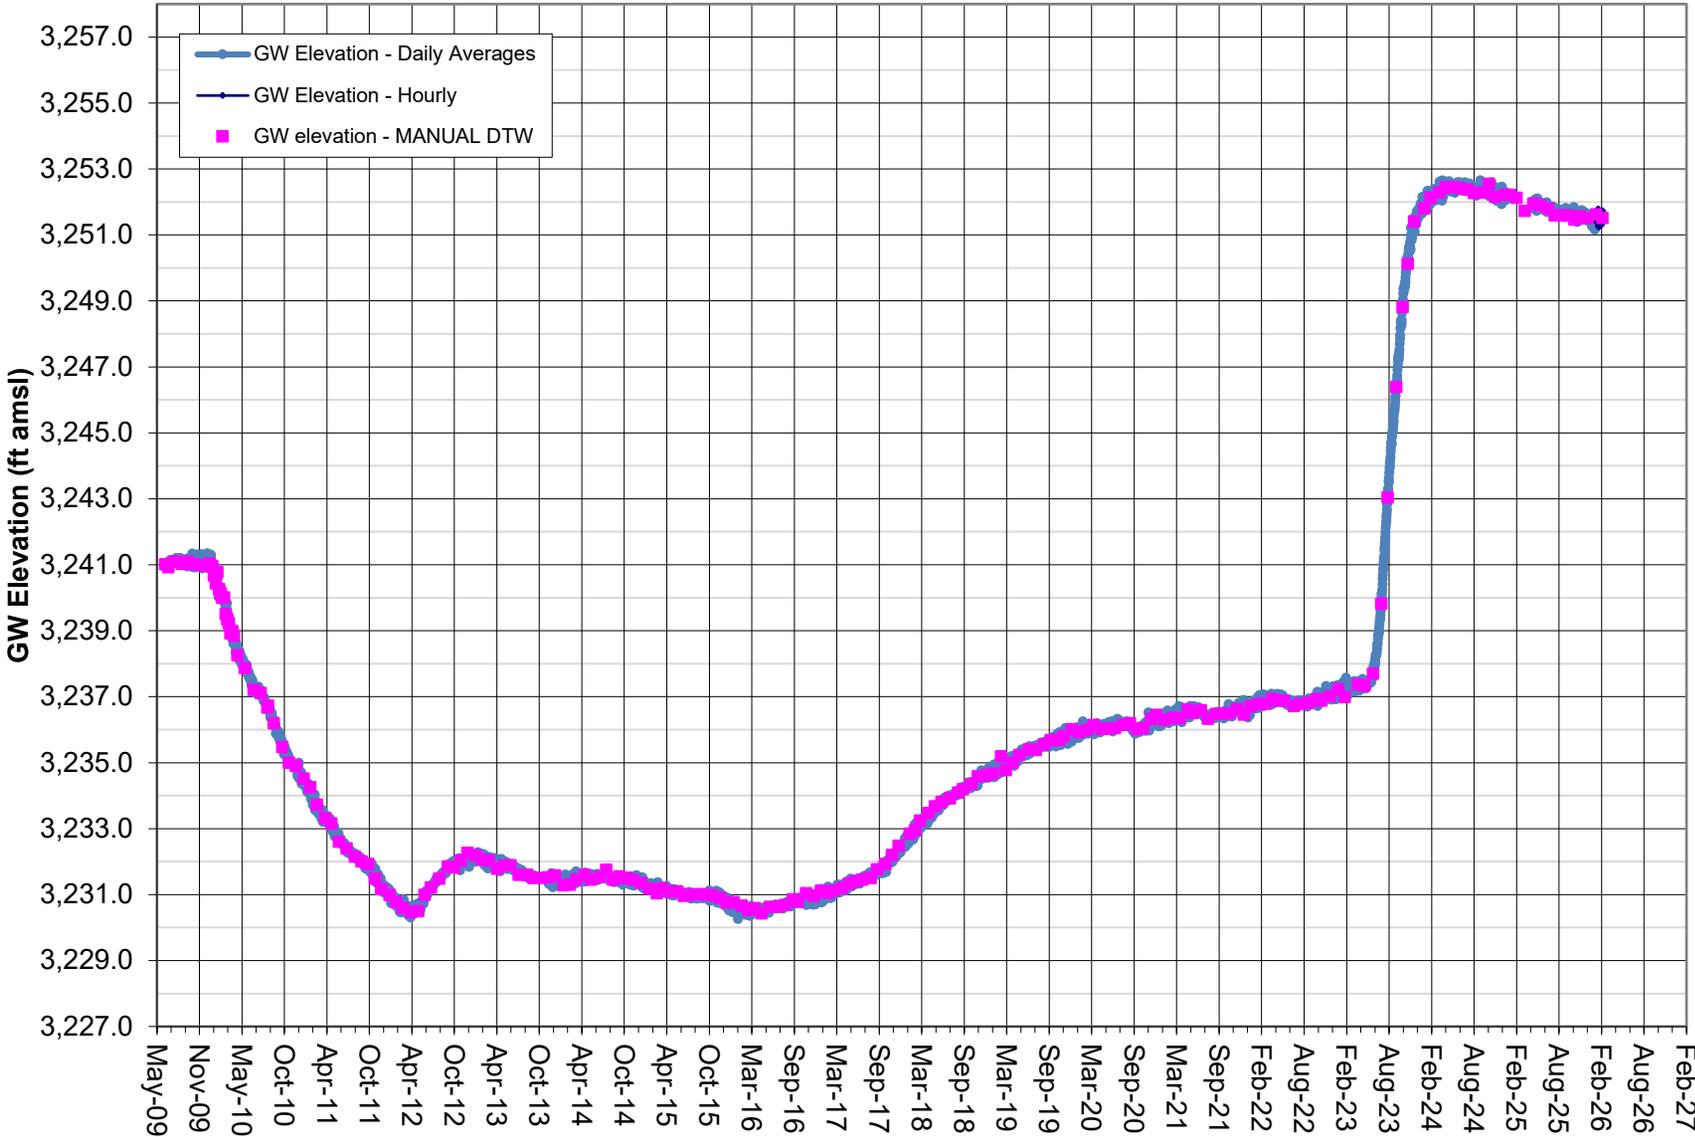
### GROUNDWATER ELEVATION DATA - Transducer RV080 - HR 2A Well

Note: Screened interval 180-300 feet.  
 Coso Operating Co. initiated Hay Ranch Project pumping on 12/25/09.  
 Transducer failed in Jan. 2025 and replaced in April 2025.

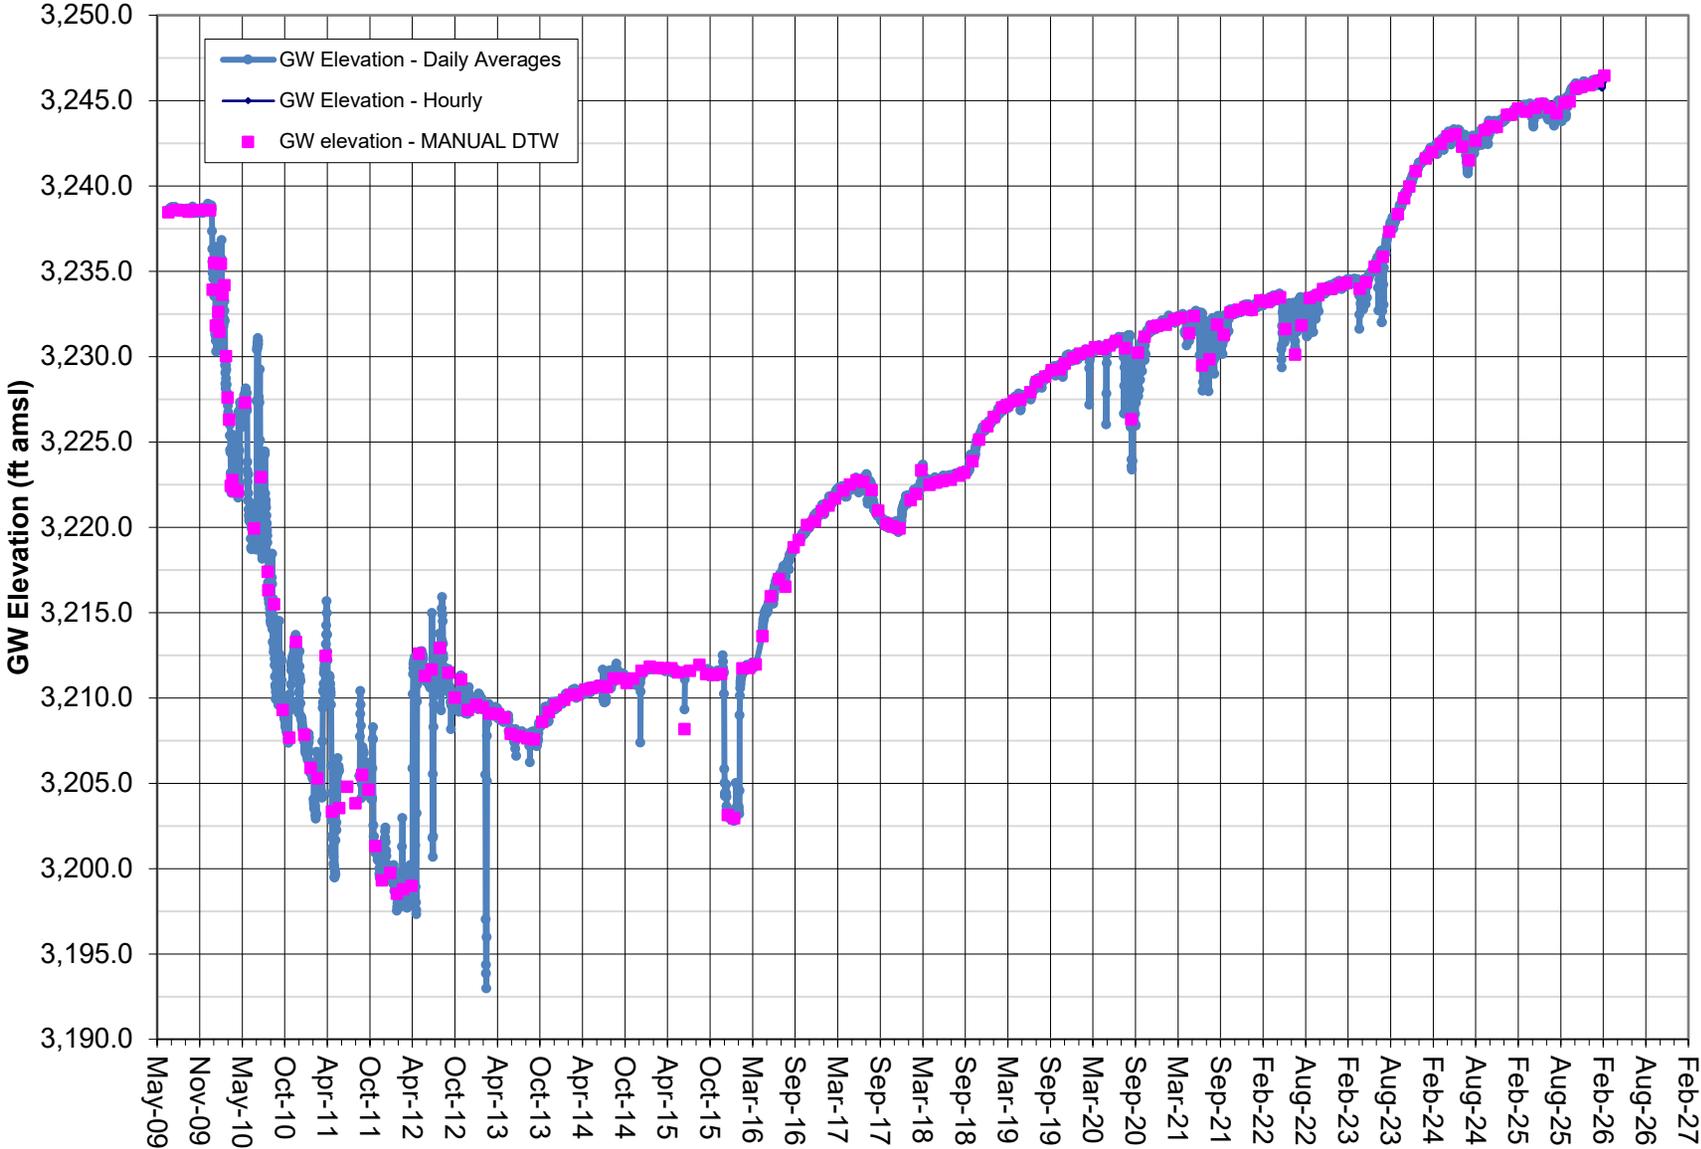
# GROUNDWATER ELEVATION DATA - Transducer RV081 - HR 2B Well

Note: Screened interval 519-584 feet.  
Coso Operating Co. initiated Hay Ranch Project pumping on 12/25/09.

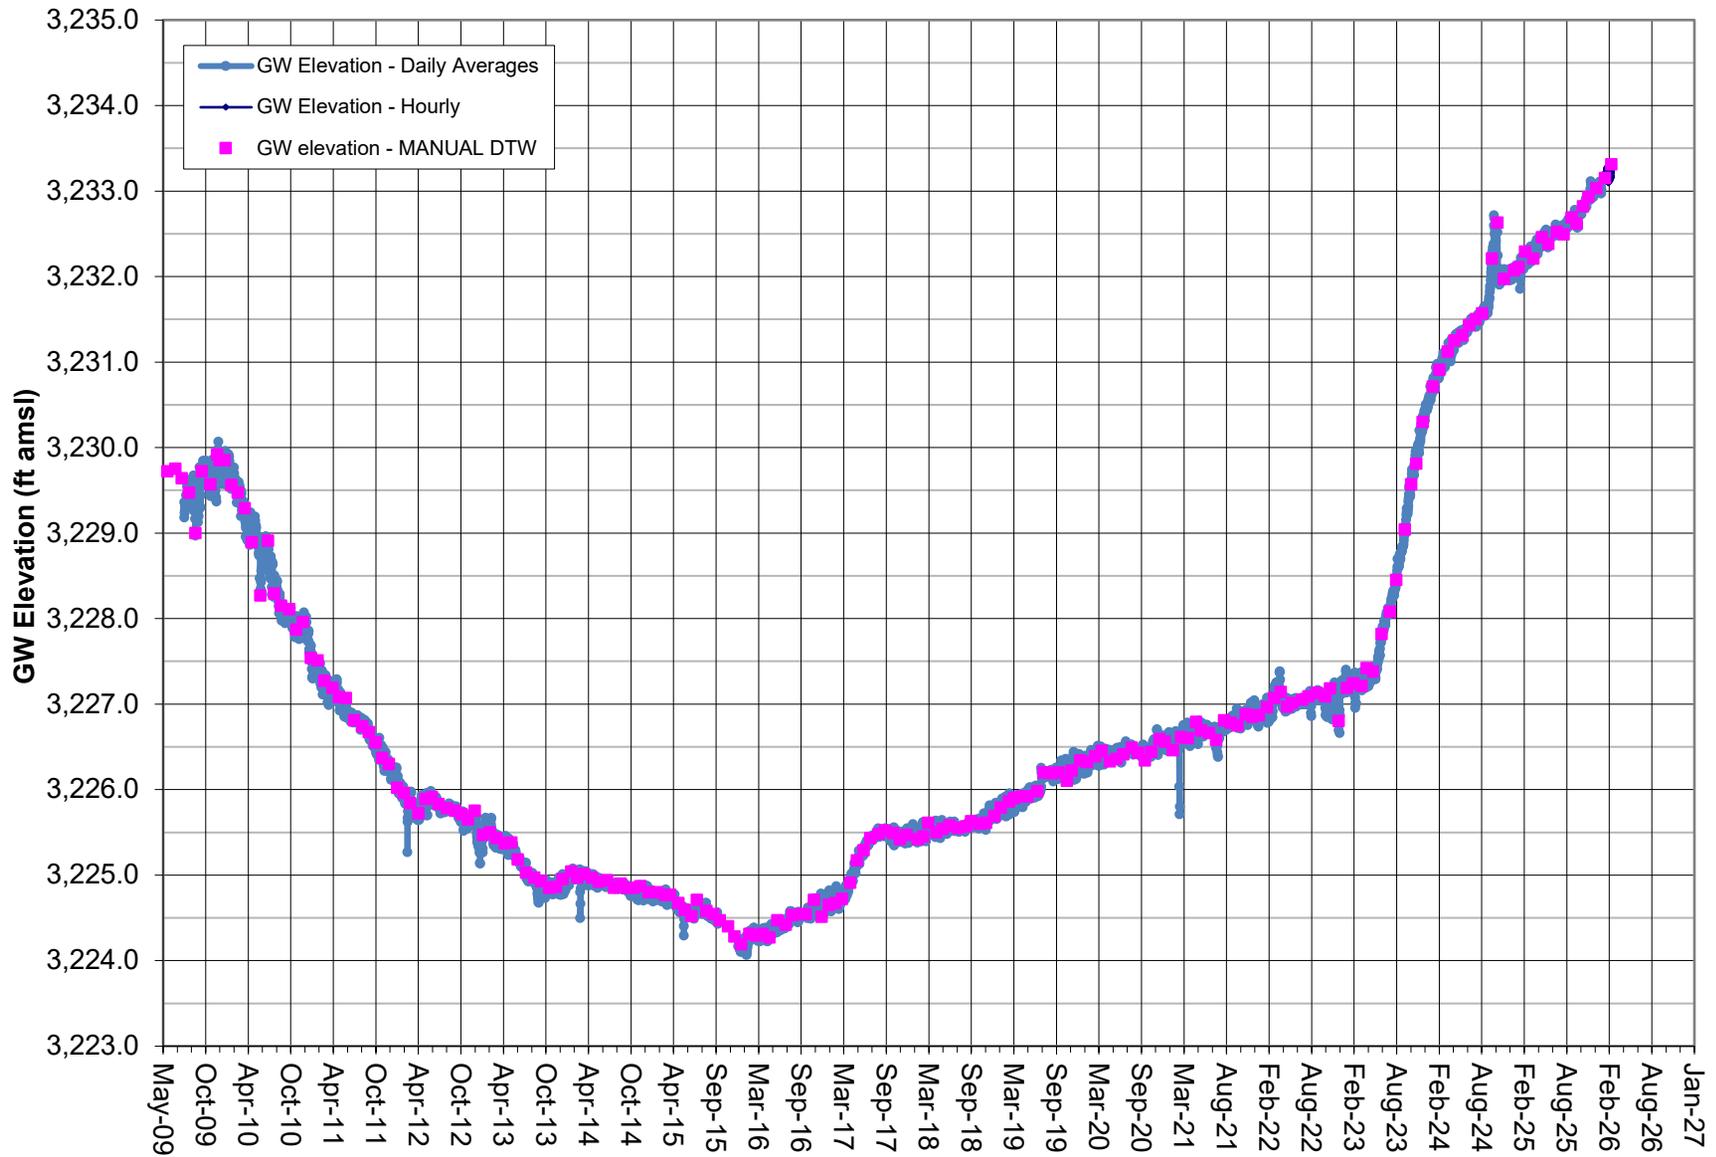
### GROUNDWATER ELEVATION DATA - Transducer RV100- Coso Junction Store#1 Well

Note: Transducer data adjusted by data logged from BaroTroll and correlated to Manual DTW.  
Coso Operating Co. initiated Hay Ranch Project pumping on 12/25/09.

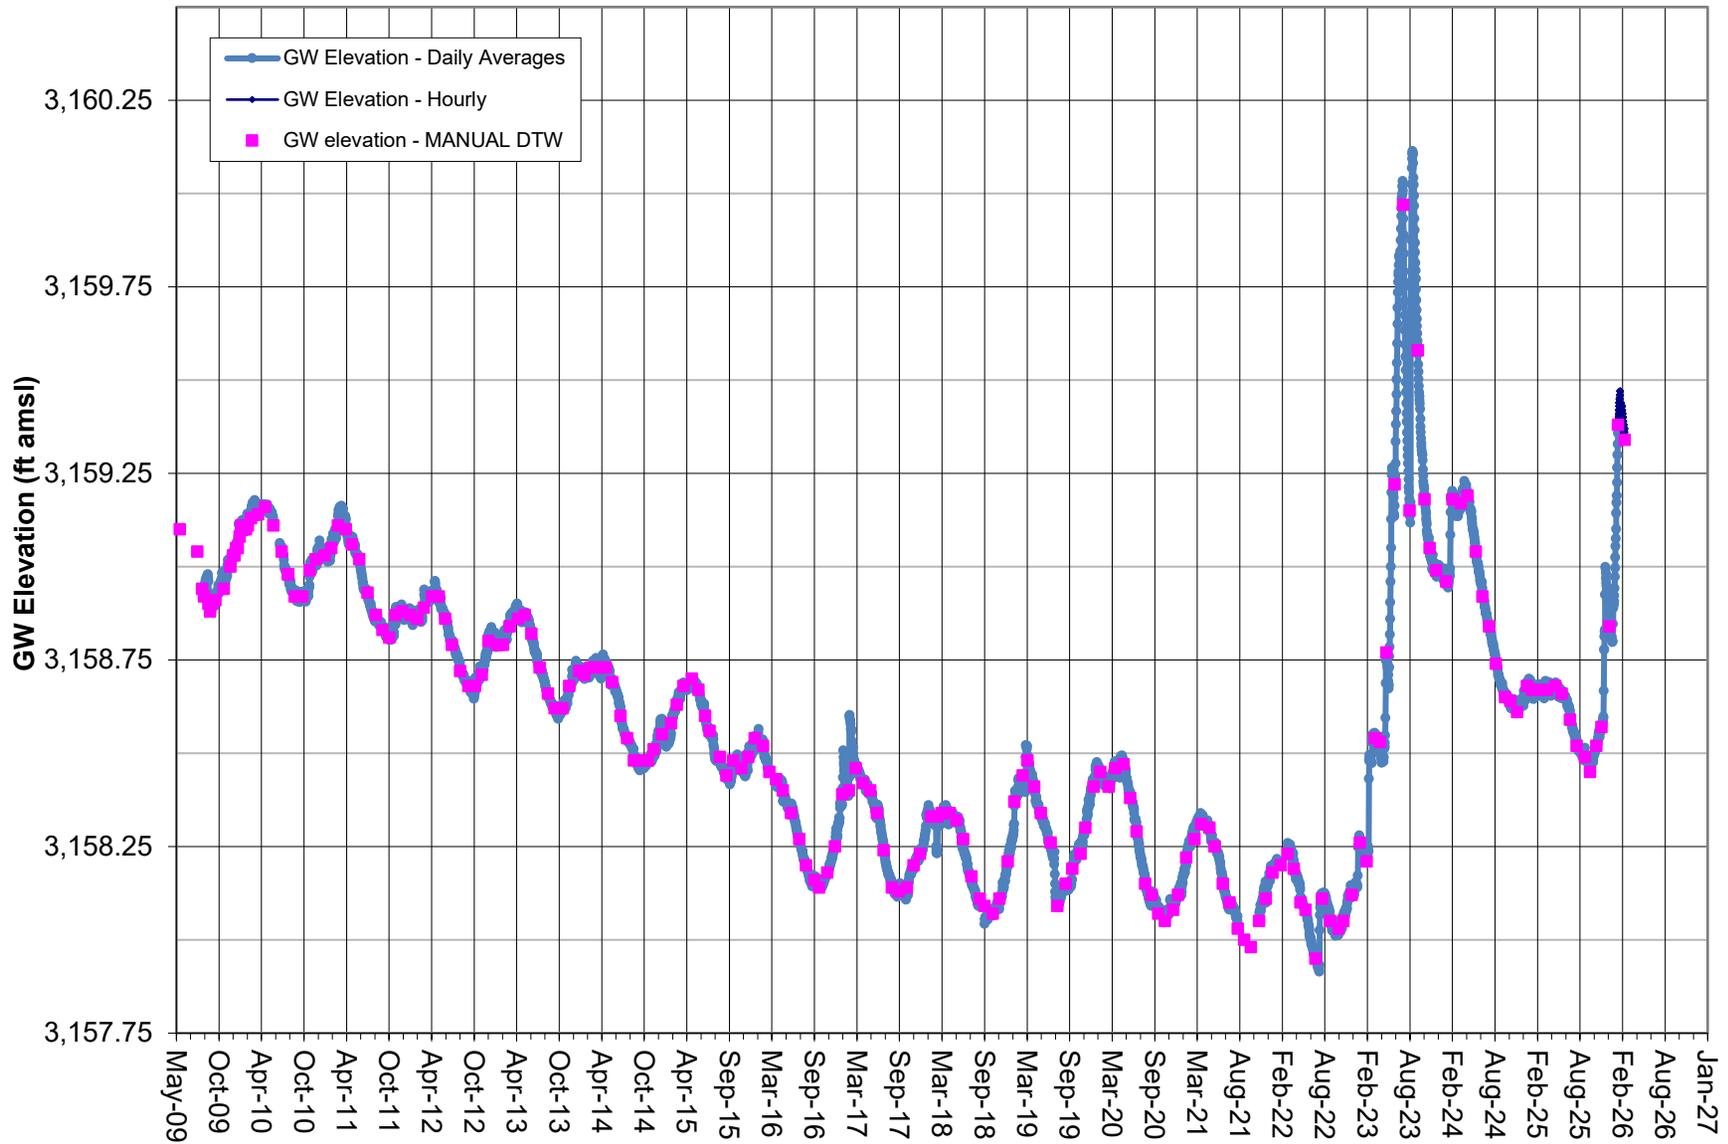
## GROUNDWATER ELEVATION DATA - Transducer RV180 - Little Lake Ranch North Well

Note: Vented transducer data correlated to Manual DTW measurements.  
 Coso Operating Co. initiated Hay Ranch Project pumping on 12/25/09.  
 Data gaps due to transducer malfunction.

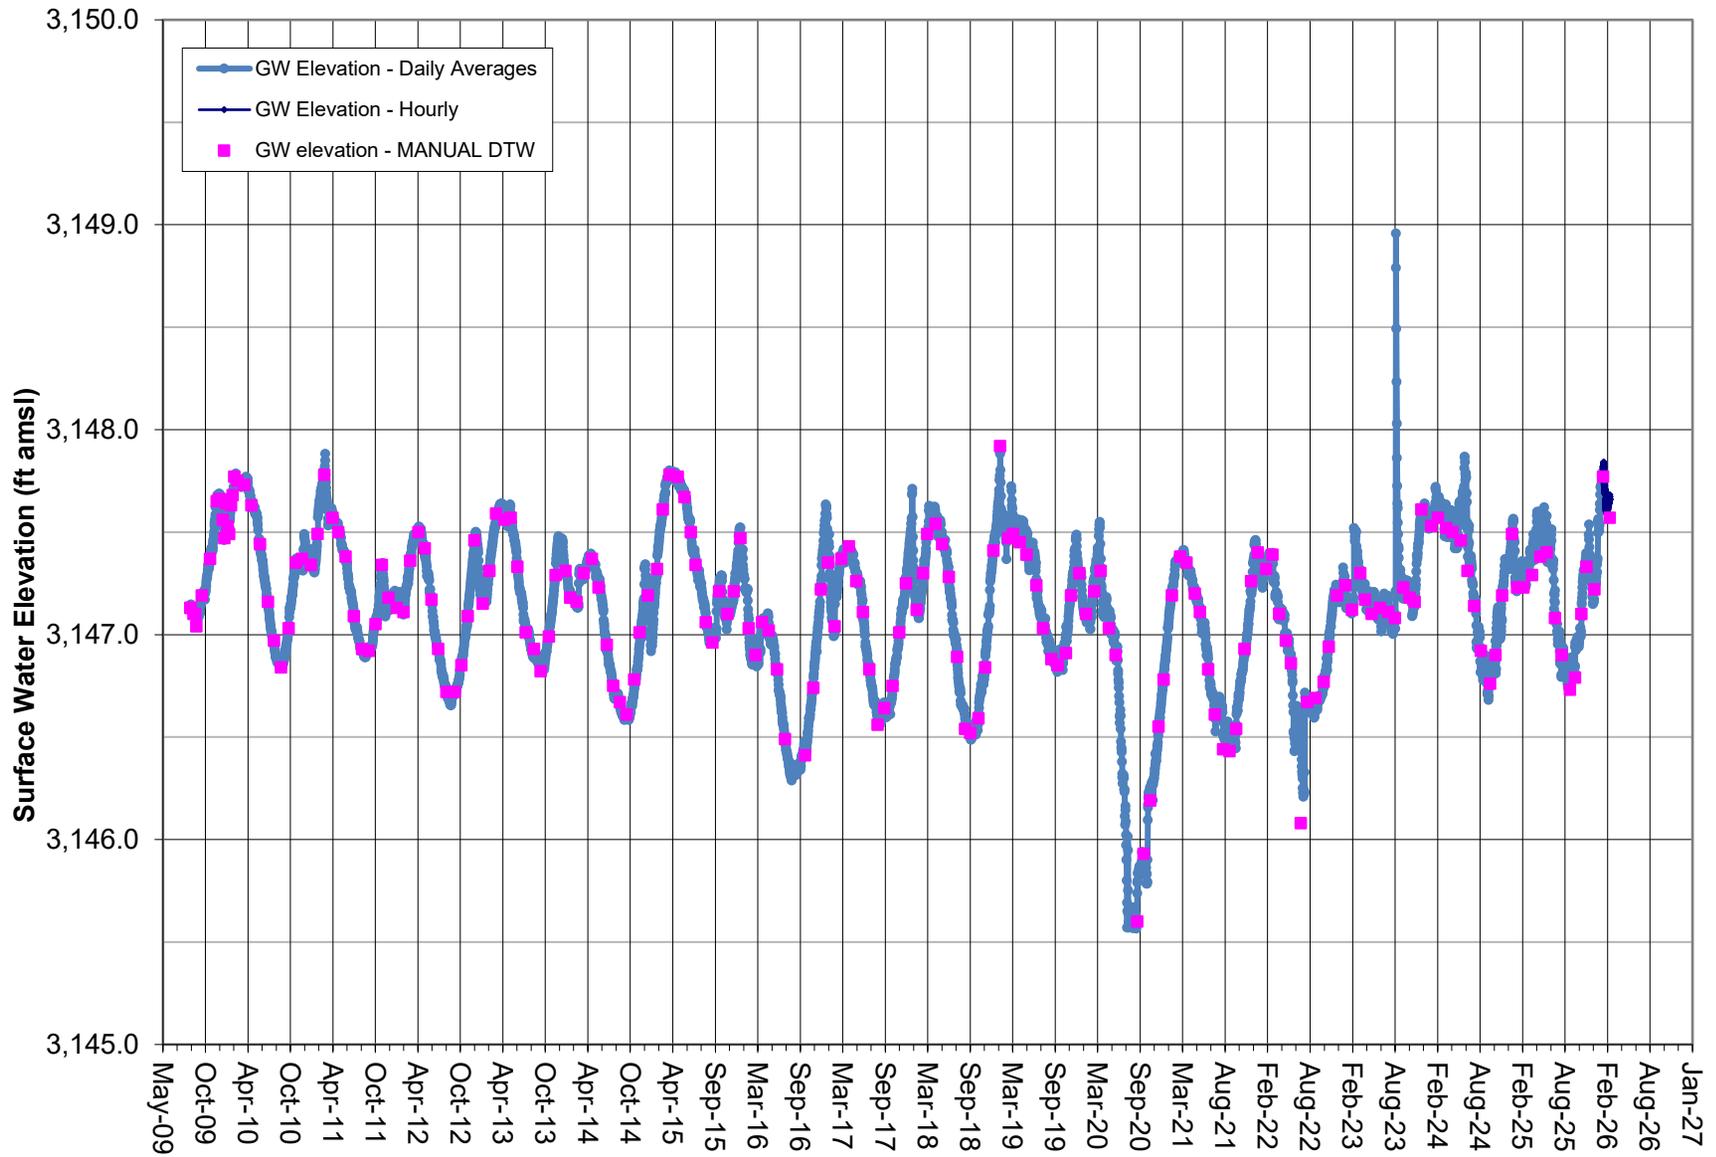
## SURFACE WATER ELEVATION DATA - Transducer RV220 - Little Lake Ranch Stilling Well (Lake Surface)

Note: Vented transducer data correlated to Manual DTW measurements.  
Represents surface water elevation of Little Lake.

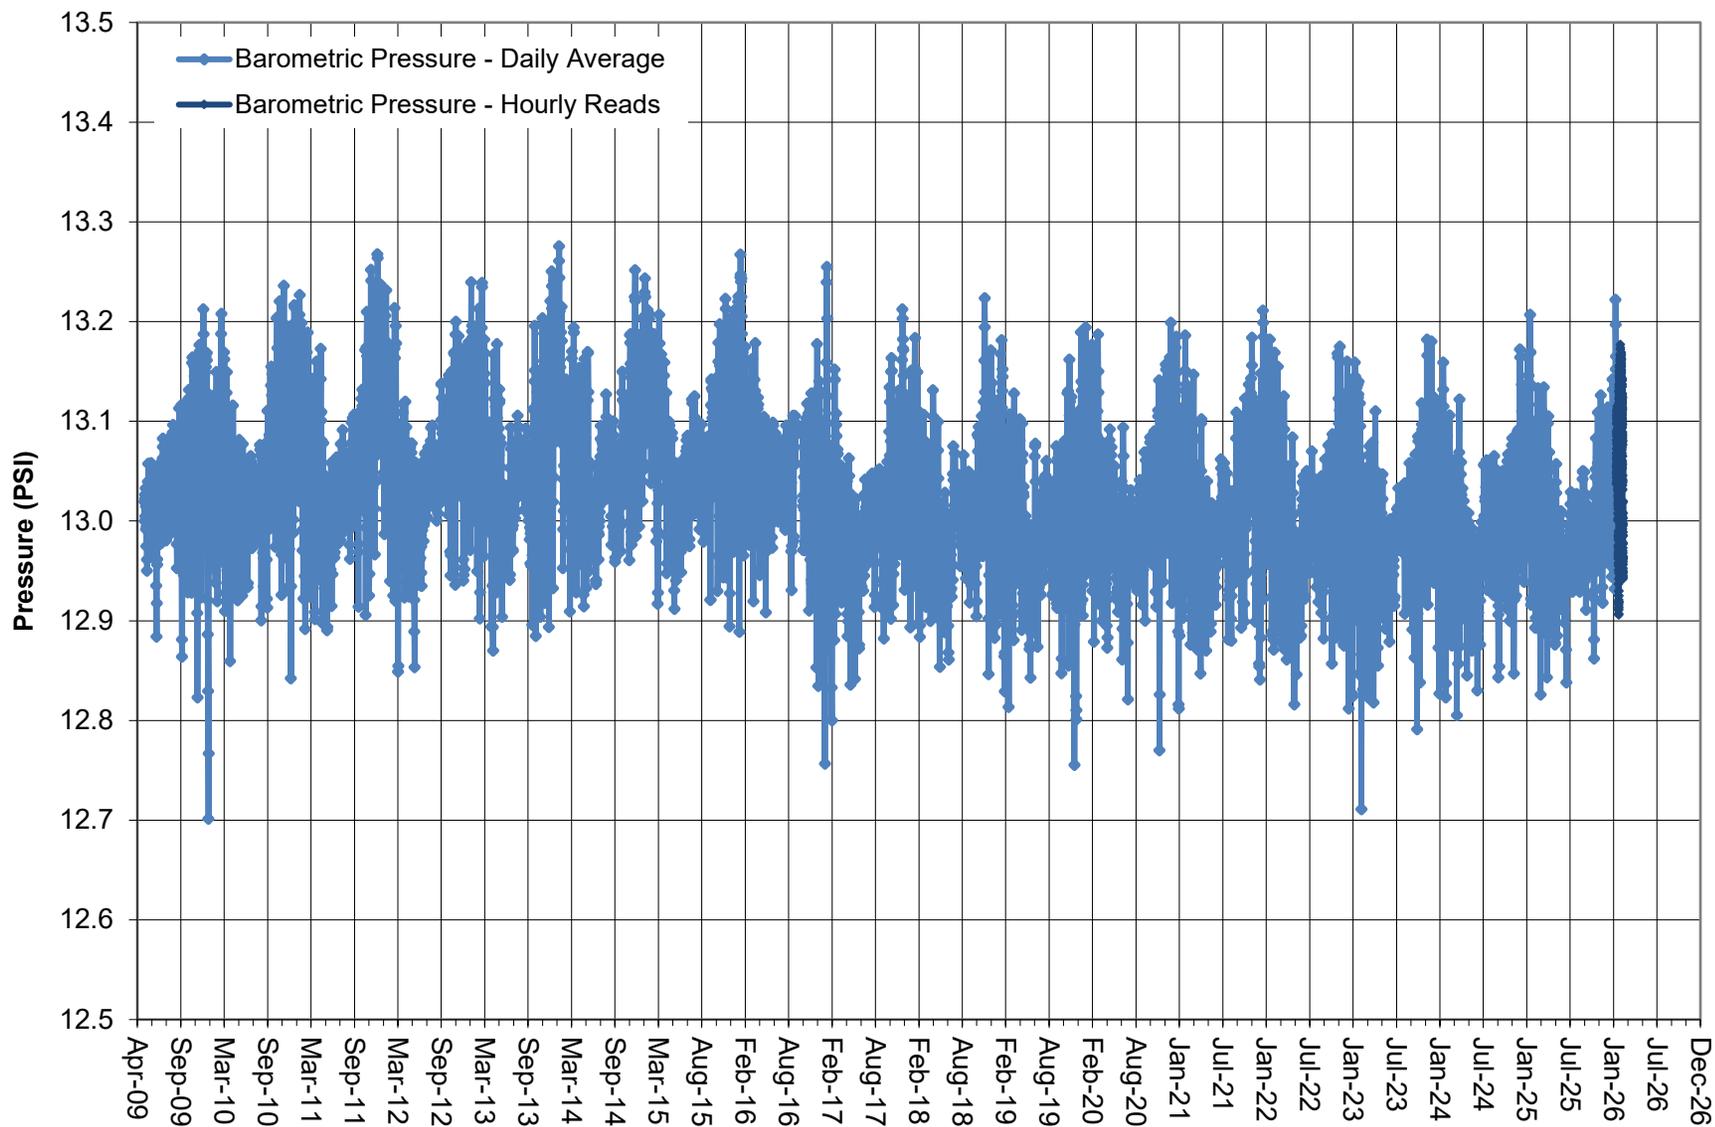
## BAROMETRIC PRESSURE as Logged by BaroTroll

Note: BaroTroll located in well casing of well HR-2B.  
Used to adjust pressure readings in non-vented transducers.
