**HAY RANCH PROJECT  
INYO COUNTY CONDITIONAL USE PERMIT  
HYDROLOGIC MONITORING REPORT**

**THIRD QUARTER 2024**

**RE: Hay Ranch Project Conditional Use Permit  
Hydrologic Monitoring Report, Third Quarter 2024  
Inyo County, California**

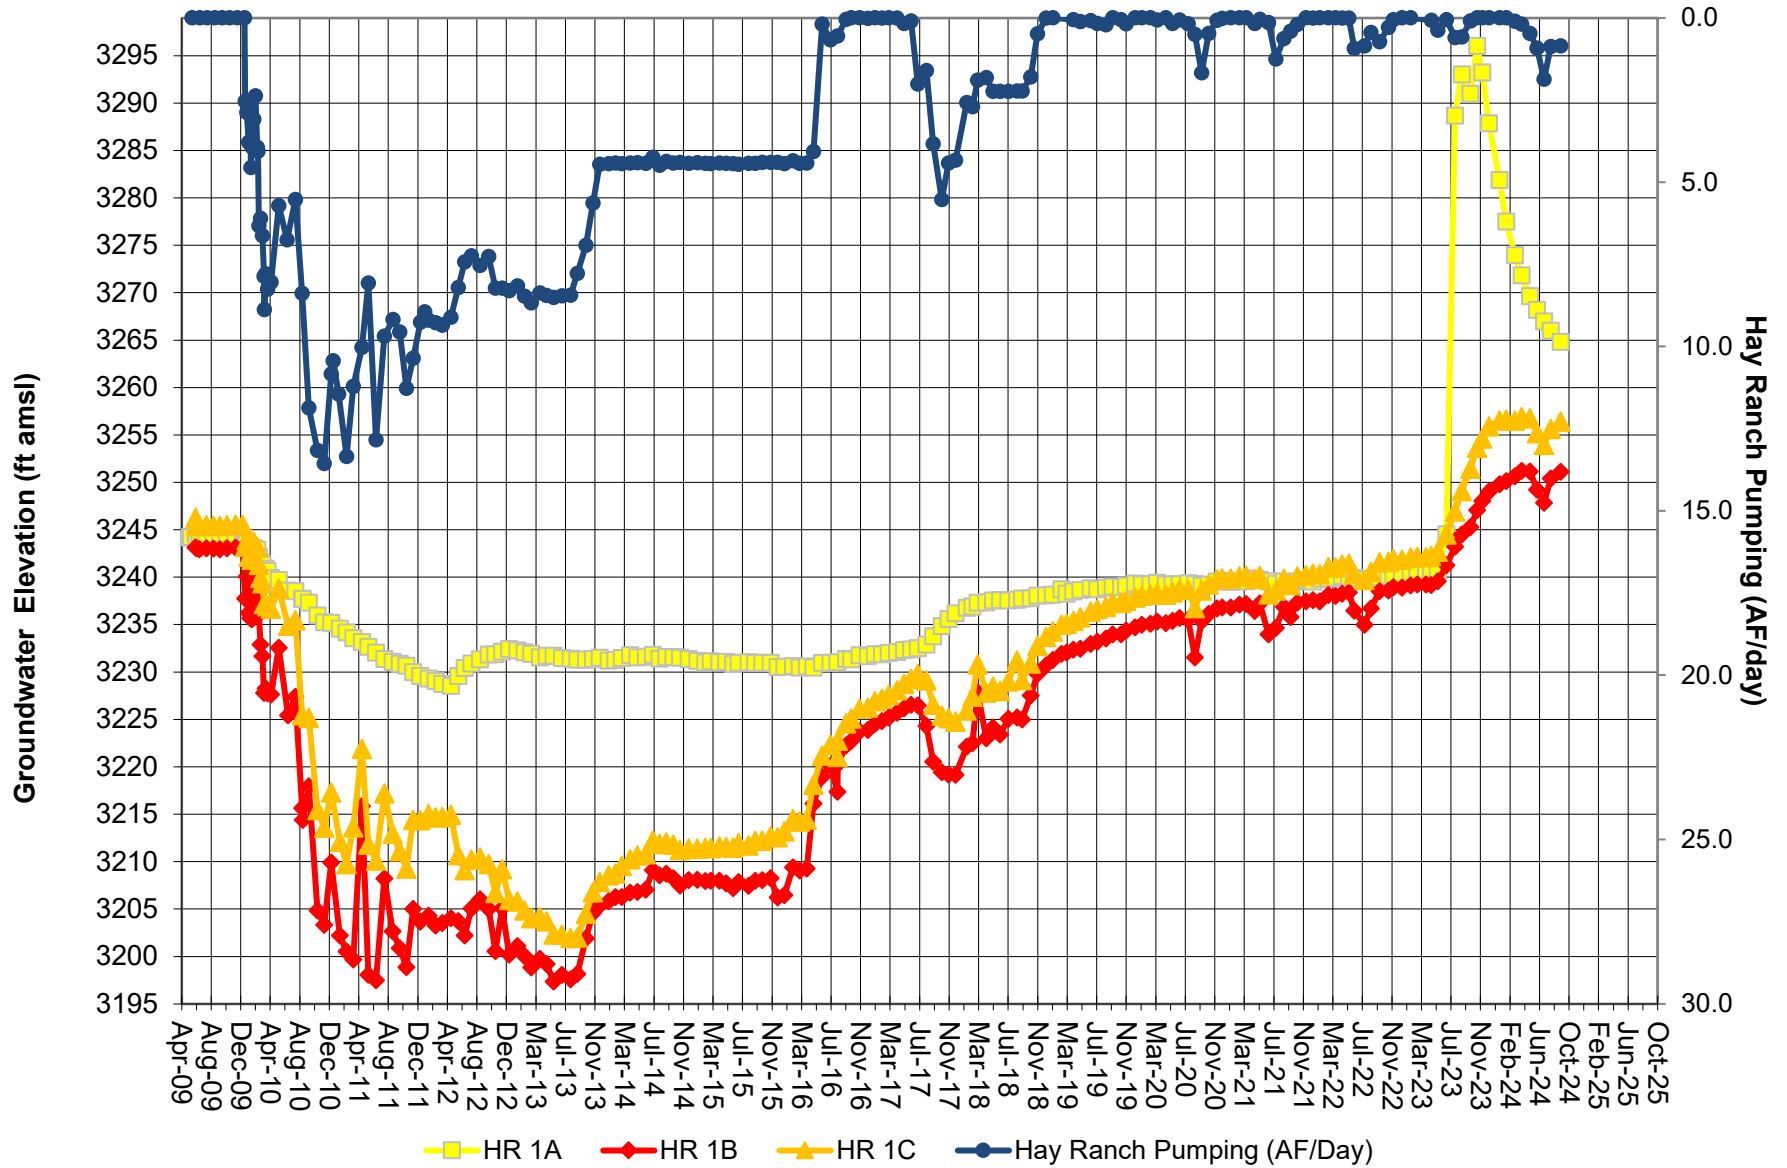
**FIGURE 4**  
 GROUNDWATER ELEVATION and HAY RANCH PUMPING  
 HR 1A, HR 1B and HR 1C

Note: Groundwater elevation data based on manual depth-to-water measurements.  
 Hay Ranch pumping is average acre feet per day.

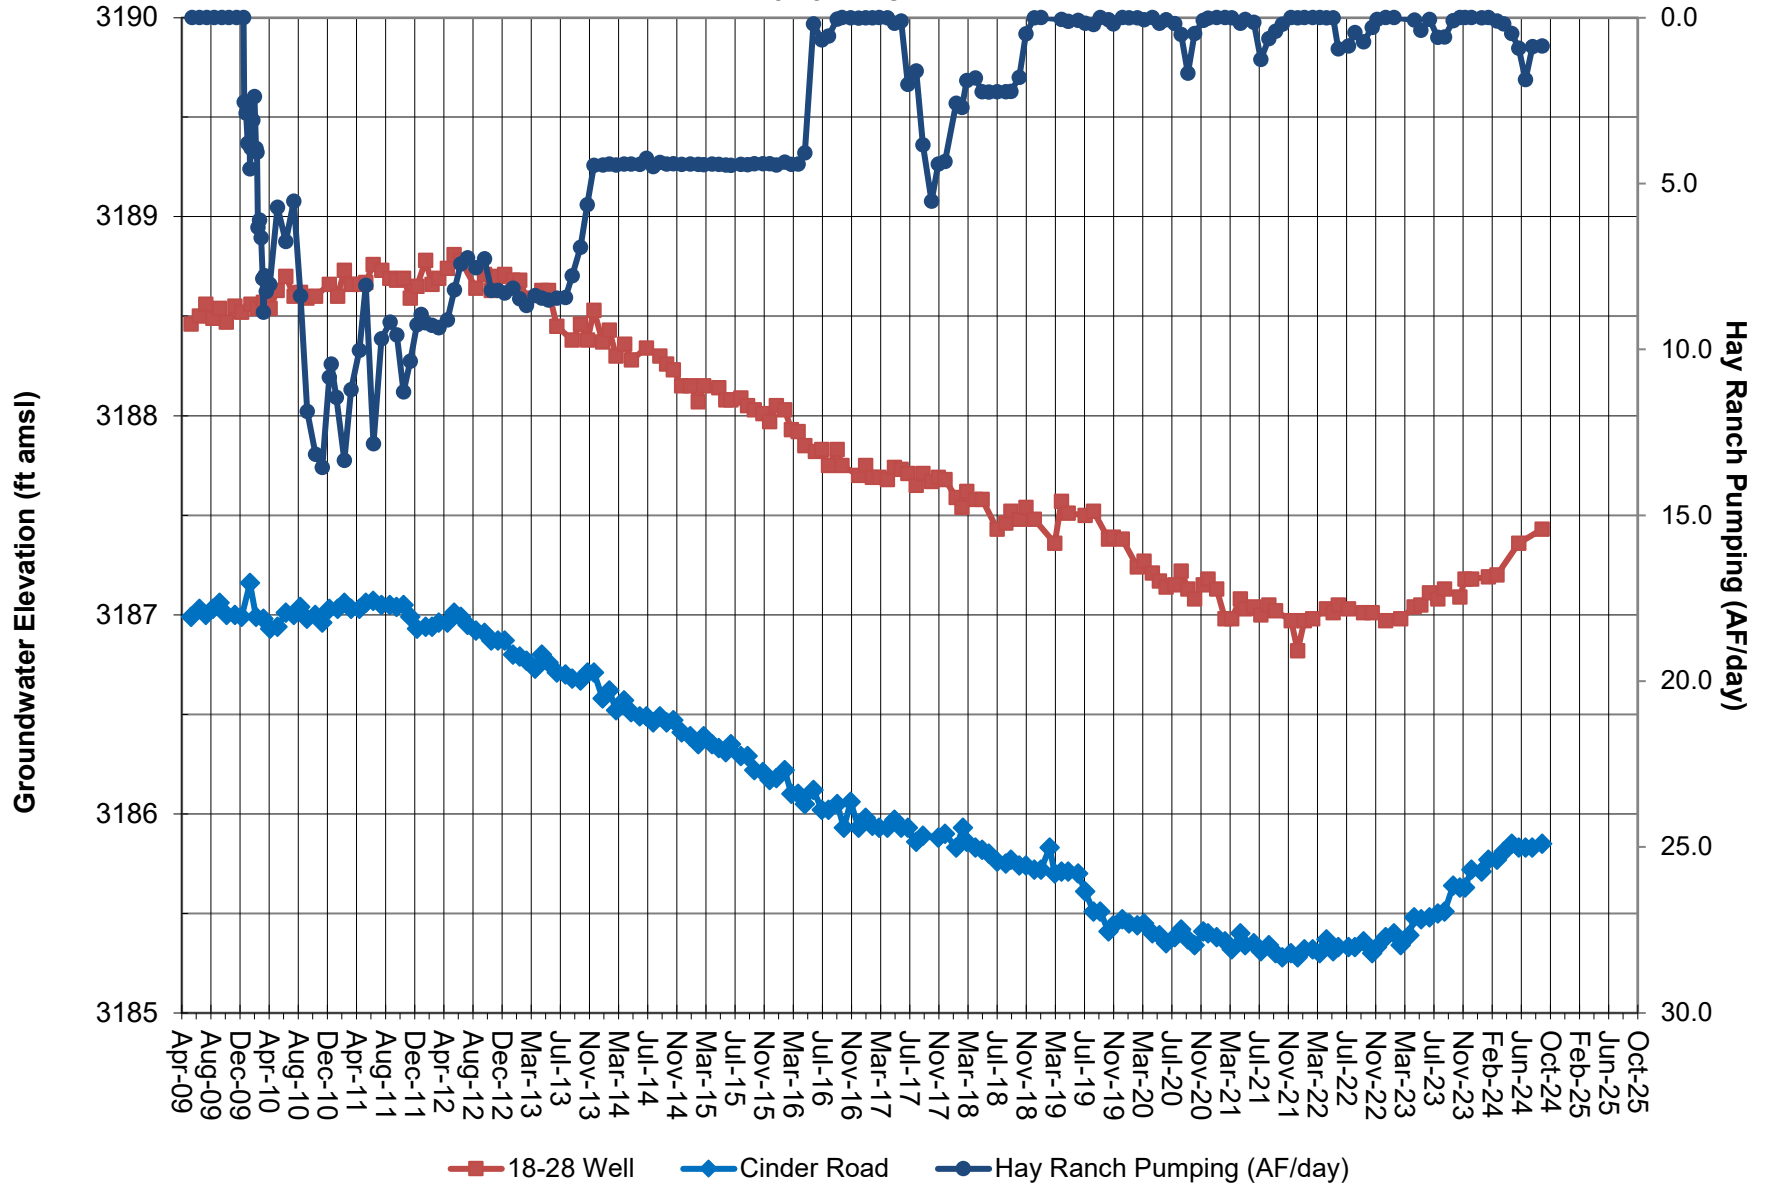
**FIGURE 9**  
**GROUNDWATER ELEVATION and HAY RANCH PUMPING**  
 18-28 and Cinder Road

Note: Groundwater elevation data based on manual depth-to-water measurements.  
 Hay Ranch pumping is average acre feet per day.

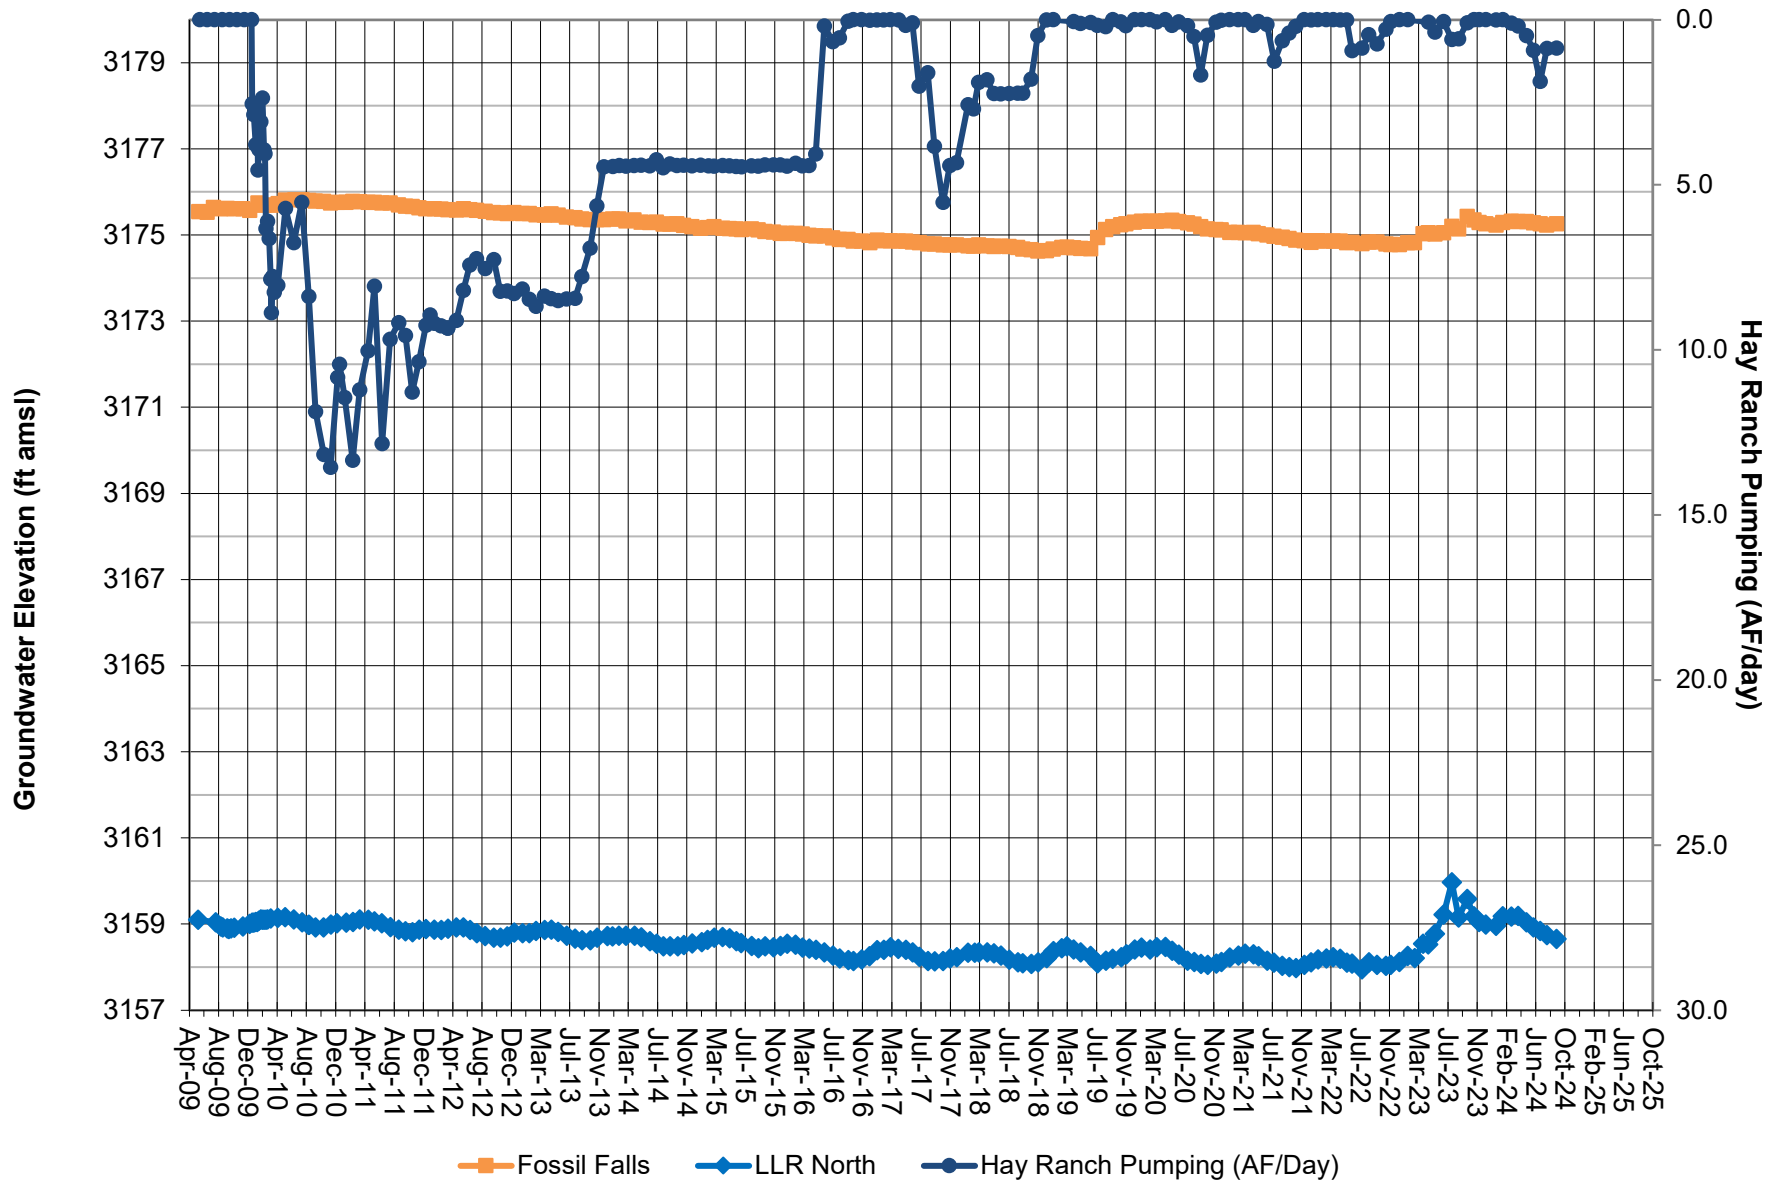
**FIGURE 10**  
**GROUNDWATER ELEVATION and HAY RANCH PUMPING**  
 Fossil Falls and LLR North

Note: Groundwater elevation data based on manual depth-to-water measurements.  
 Hay Ranch pumping is average acre feet per day.
