**HAY RANCH PROJECT
INYO COUNTY CONDITIONAL USE PERMIT
HYDROLOGIC MONITORING REPORT**

FOURTH QUARTER 2024

**RE: Hay Ranch Project Conditional Use Permit
Hydrologic Monitoring Report, Fourth Quarter 2024
Inyo County, California**

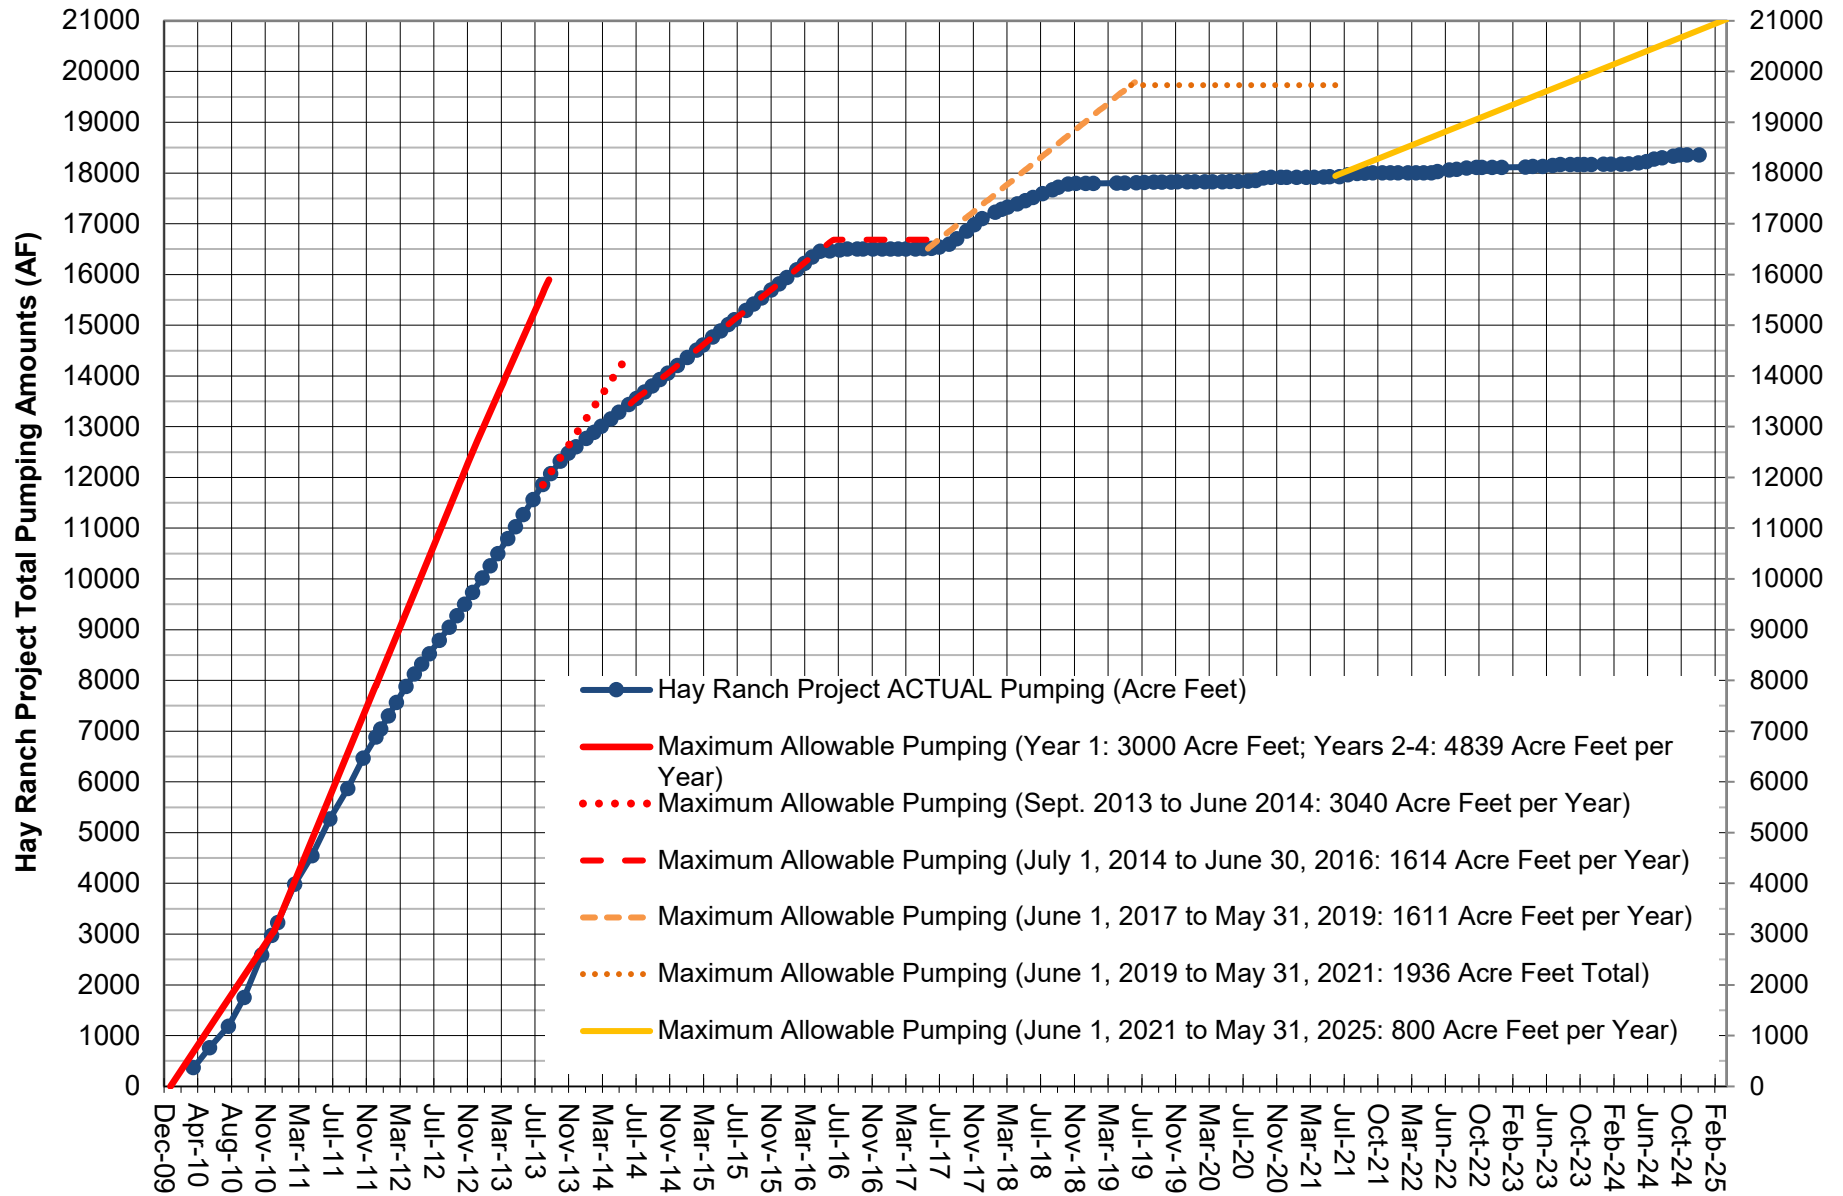
Note: The "maximum allowable pumping" is based on a pumping rate of 3000 AF/yr for 12/09 to 12/10, 4839 AF/yr for 1/11 to 8/13, 3040 AF/yr from 9/13 to 6/14, 1,614 AF/yr from 7/14 to 6/16 and 1611 AFY for 6/17 to 5/21.
